Case Study....

PITCHMASTIC PmB

Project : Tyne Tunnel Phases 1,2,3
Location: Newcastle Upon Tyne, United Kingdom
Client: Newcastle City Engineer

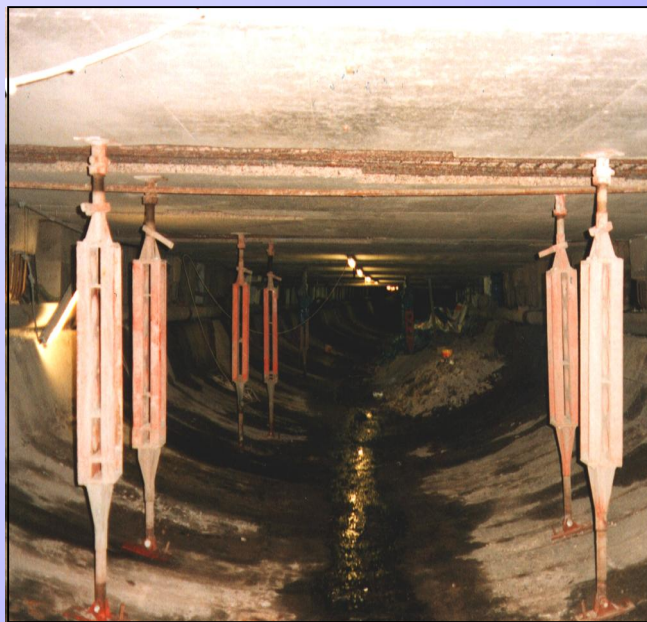
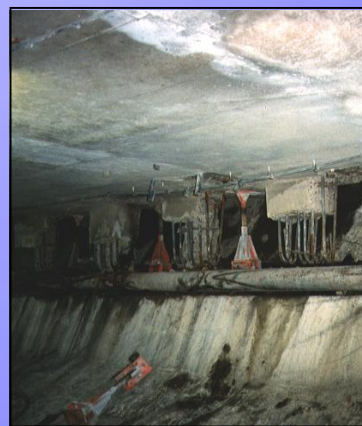
Images:

The road slabs and support legs in the Tyne Tunnel were suffering from reinforcement corrosion. The company was appointed to undertake concrete repair in the tunnel. Particular attention was given to the design of the temporary support structures as substantial areas of concrete were removed; the intention being to maintain traffic flow at all times.

The techniques used were high-pressure water cutting and sprayed concrete with all concrete soffit areas receiving an anti-carbonation coating. Stub columns were waterproofed using Pitchmastic's PmB polyurethane spray applied system.
