Case Study....

Project : Luxury Apartment Block

Location: Taiwan

Waterproofing

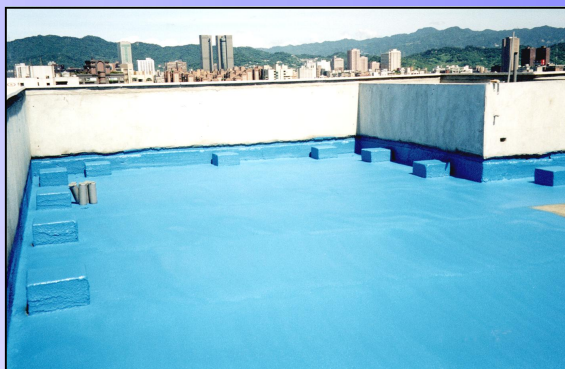
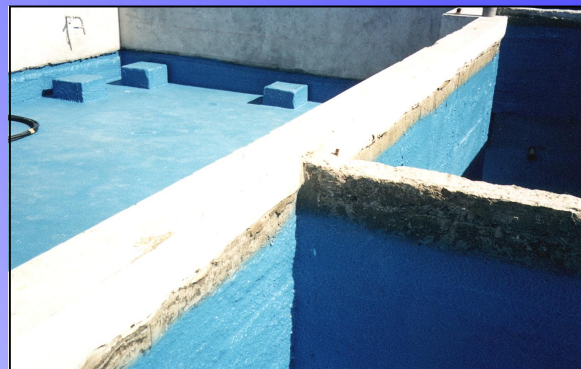
Images:

In this instance, both roof areas and vegetation planters were protected by PmB elastomer. Following the installation of the PmB membrane paving to the leisure areas was carried out. In the waterproof planters soil was placed directly on top of the membrane.

PmB polyurethane was selected to provide a highly bonded seamless elastomeric membrane unaffected by thermal movement. This high-grade technology assures leak free integrity over the extended term. The client gains a significant benefit by reducing cost in use and having a maintenance free system.
