# Case Study....

**Project :** New Equine Pool  
**Location:** Newmarket, United Kingdom  
**Main Contractor:** French Kier Anglia  
**Client:** Godophin Management Company

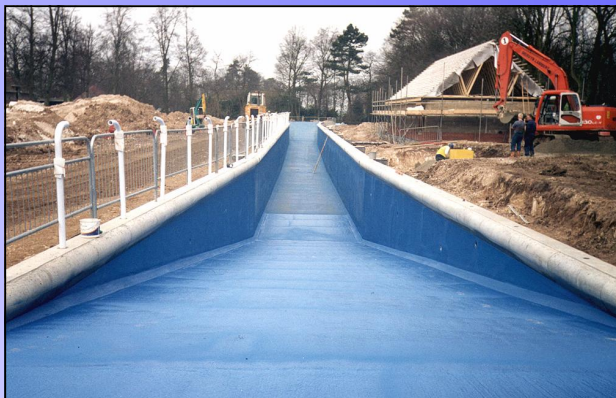
**Image:**

PmB was specified for the waterproof lining on this new equine pool at Stanley House Stables in Newmarket following its successful use on two similar structures in the UAE.

The system was installed to the internal faces of the pool to prevent water leakage and to protect the structure from corrosion.

In view of the need for impact resistance inflicted by the horses whilst entering and swimming within the pool, the membrane was applied at varying thicknesses of up to 8mm in places.

Once completed the PmB system was subject to quality testing, including adhesion and a full electronic survey to ensure integrity throughout the installation.
